The Behaviour Of Railway Level Crossings: Insights Through Field Monitoring

# THE BEHAVIOUR OF RAILWAY LEVEL CROSSINGS: INSIGHTS THROUGH FIELD MONITORING.

**Key words:** level crossing, ballast, railway, railroad, geophones, digital image correlation, transition

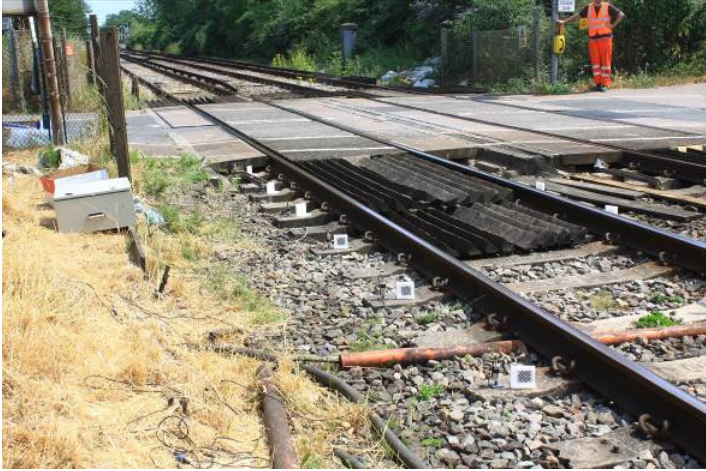
**Figure 1: Photo of level crossing looking towards the nearby station in the direction of the train movement on the near track**

The study site is shown in Figure 1. The site is underlain by soils of the London Clay formation (clay, silt and sand). Throughout this paper, distances are given from the edge of the level crossing on the side where measurements were carried out. At this location there are two tracks and the side of the track monitored is on the nearside of Figure 1 with trains moving from right to left. The start of a platform at a nearby station is about 200 m beyond the end of the level crossing, in the direction of train travel. A renewal took place through the station on 24 October 2012 but although this renewal was originally intended to include the crossing it was curtailed 35 m before the crossing, on the opposite side of the crossing to the monitoring location.

The level crossing is surfaced with Bowmac concrete panels, visible in Figure 1 (and also in Figure 5, see later). The Bowmac concrete panels rest on longitudinal concrete beams at the termination of the blacktop (tarmac), and on rubber wedges inserted into the rail webs to provide a roadway (Figure 1). Beneath the Bowmac panels, the track support structure is sleepers on ballast.

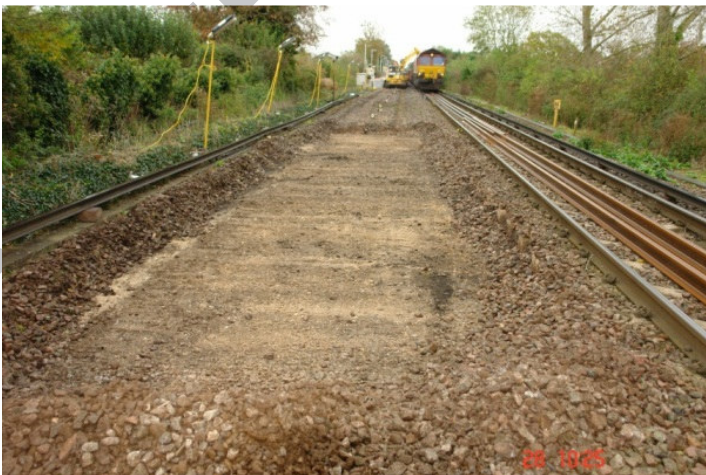
**Figure 2: Formation being prepared for track renewal looking towards the nearby station from the level crossing**

Figure 2 shows the track bed being excavated in preparation for the renewal. The renewal permitted an assessment of the likely trackform below the study site (where there was no renewal). Figure 2 shows that the ballast is partly fouled and a brown sandy / silty / clayey formation, probably intermixed with ballast fragments has started to be exposed. Neither a geotextile nor a sandblanket are present.

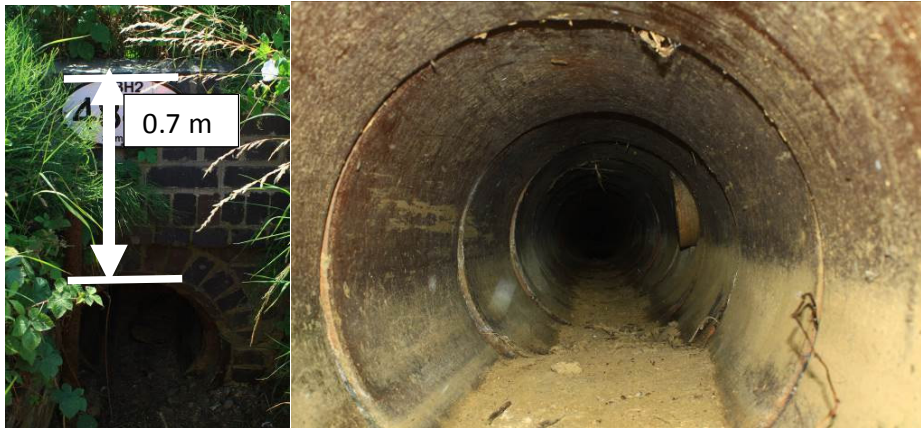
**Figure 4: Culvert below the level crossing**

A culvert passes below the track on the side of the level crossing studied; the inside of the top of the culvert was estimated to be at 0.7 m below sleeper level and is shown in Figure 4. The culvert represents a potential hard spot beneath some of the sleepers near to the crossing.

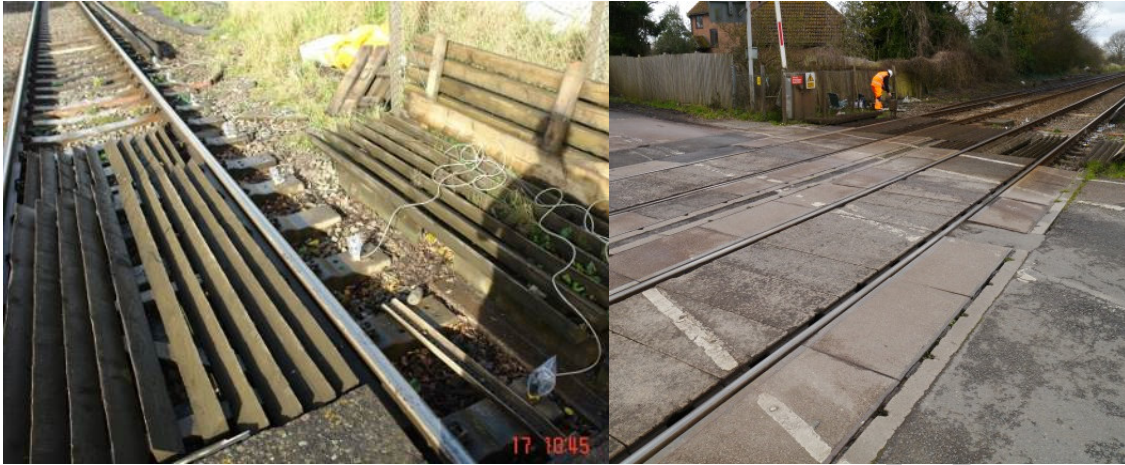
**Figure 5: (a) Arrangement of geophones and (b) level crossing viewed from the opposite side of the road from the instrumented section**

Geophones and digital image correlation (DIC) of video images following the principles described in Bowness et al (2007) were used to determine track movements during train passage along a run of 14 sleepers up to the crossing as shown in Figure 5. The geophones were placed on 7 alternate sleepers from the termination of the third rail on the approach to the crossing. The geophones are visible in Figure 5 as small cylinders covered in plastic bags with cables connecting them to a Campbell 9000 data logger (Campbell Scientific, 2014) situated beside the track and out of view. The geophones are attached to small metal brackets glued temporarily to the sleepers.

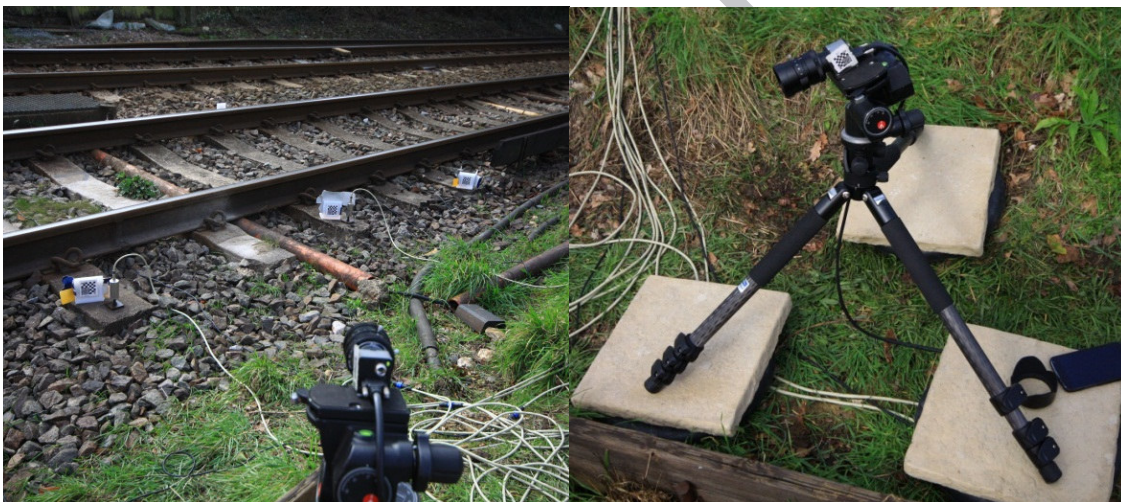
**Figure 8: (a) targets on sleepers and (b) camera set up**

To aid the analysis and provide a reference for scaling it is usual (although not a requirement of the system) to attach square textured targets to the sleeper ends (Figure 8a). Filming of these targets generates a video file which is then converted to a series of jpeg images for analysis. The analysis is carried out using a variant of the digital image correlation technique described by Bhandari *et al.* (2012). The technique involves defining measurement (tracking) points and identifying corresponding patterns at these points in the subsequent images using a normalized cross-correlation algorithm. The basic assumptions are that the pattern is approximately constant between successive images and that the local textural information is unique. To allow maximum flexibility a bespoke front end Matlab (Mathworks, 2012) script is used which permits a target (Figure 8a) of known dimensions to be selected. The movement is then determined for a subset of pixels of user defined number in each image in sequence, relative to the initial image.

Wind influence on the camera position is minimised by placing the camera as close as possible to the ground with the tripod legs set as far apart as possible. There is little wind during train passage, but usually a strong gust after the train has passed. There is also real high frequency content in the sleeper movements due to sources such as rail roughness, which it may be desirable to remove so as to observe the principal sleeper motions. This high frequency content is removed from the data using a post analysis 4<sup>th</sup> order low pass Butterworth filter to a specified high frequency cut off, typically between 15 Hz and 30 Hz. Even having applied all these techniques, there will remain some spurious sources of movement in the DIC data that will vary from site to site in accordance with the camera position relative to the track, the specific ground conditions and weather (wind) on the day. Repeated deployment of the system has shown that embankments (particularly over softer formations) are usually more problematic than cuttings for ground-borne vibration, and the best data are obtained when the camera can be situated on a firm support away from the tracks.

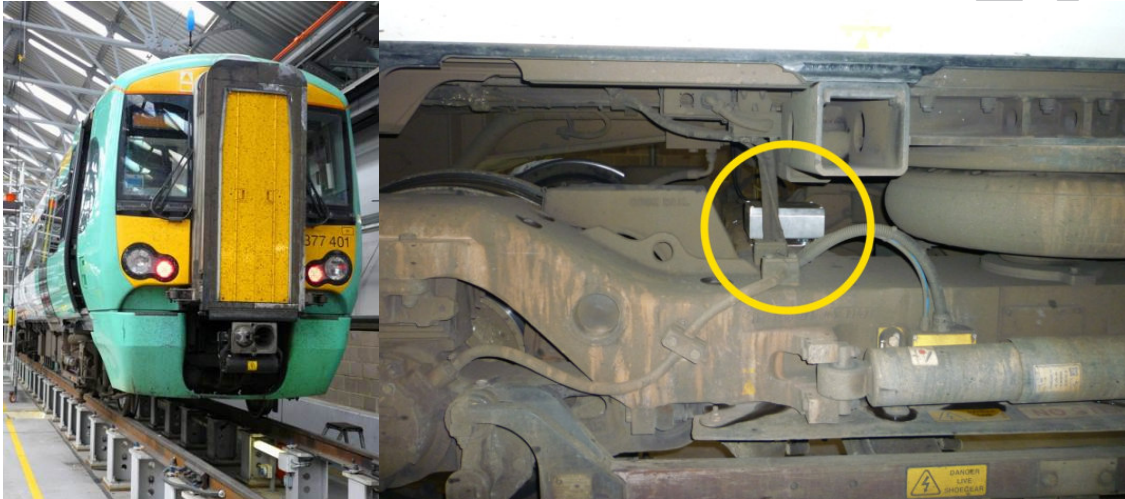
Figure 9: Class 377 train and location of inertial measurement box

In addition to the TRC data, an in-service Class 377 train has been instrumented by the University of Birmingham (UoB) to obtain more frequent, albeit less accurate, track geometry measurements. An inertial measurement system is attached to a bogie to determine the orientation and trajectory of the bogie. From this information the left and right rail vertical geometry can be inferred (Weston *et al.*, 2007). As the bogie is separated from the rails by the primary suspension and its movement driven by both the leading and trailing wheelsets on the bogie, the left and right rail geometry are estimated with some error. Despite this, the results are comparable to the NR TRC at wavelengths longer than 3 m, as will be demonstrated later. Figure 9 shows the class 377 train and the location of the Birmingham instruments.
